FACILITY CONDITION ASSESSMENT

R. C. Icabone Swimming Pool
1131 College Ave.
Cañon City, CO

Terracon Project No. BE186084

R. C. Icabone Swimming Pool ■ Cañon City, CO
December 5, 2018 ■ Terracon Project No. BE186084

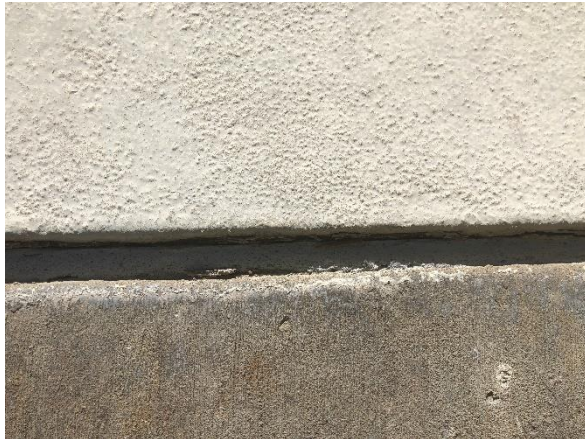
Photo #1: Joint between the pool liner and coping and pool deck.

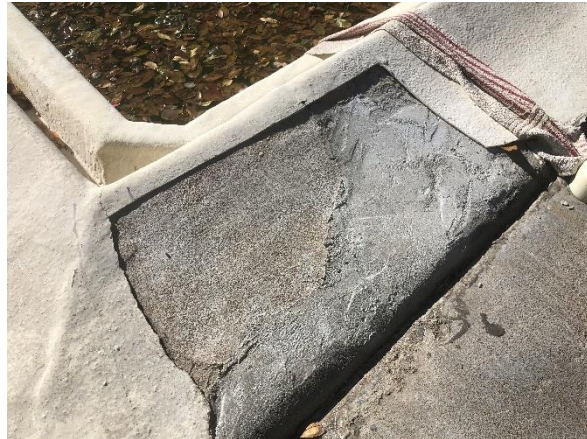
Pool Finish Degrading pool finish was observed on site.	The pool finish on both bodies of water has exceeded its lifespan. The finishes were believed to be installed in 2002 (16 years ago). The assumed life expectancy for a pool liner is 10 years.

Photo #2: Pool liner failing.

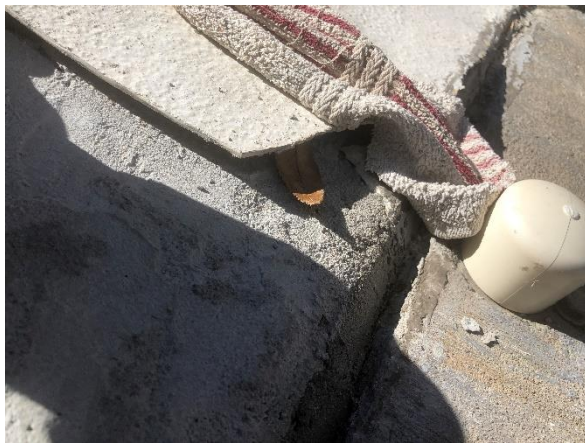
Photo #3: Further detail of pool liner failing. (Continuation of Photo #2)

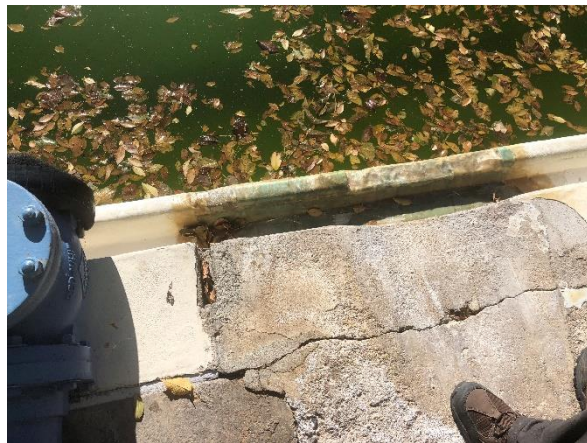
Photo #4: Location of pool slide entry. Location shows major wear of pool liner at slide entry point.

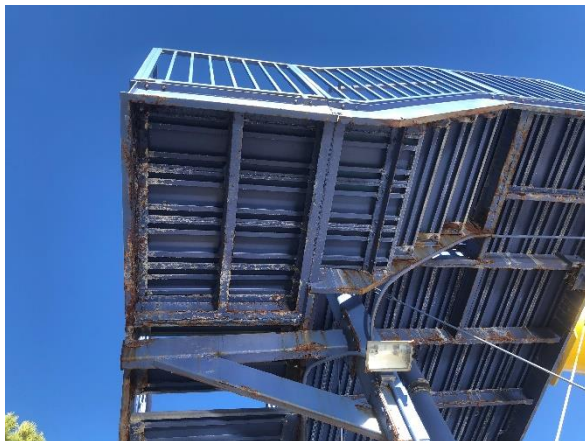
Photo #5: Corrosion at pool waterslide structure

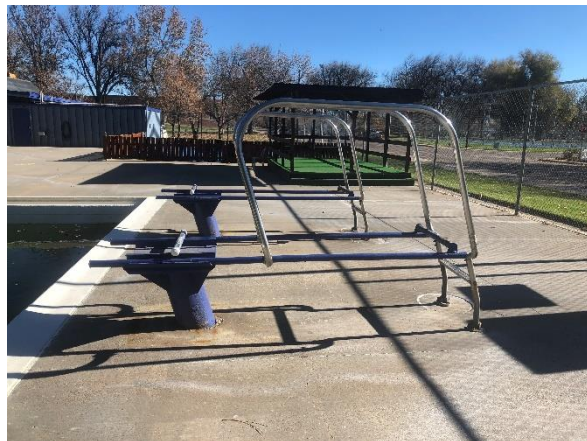
Photo #6: Diving board locations in diving well.

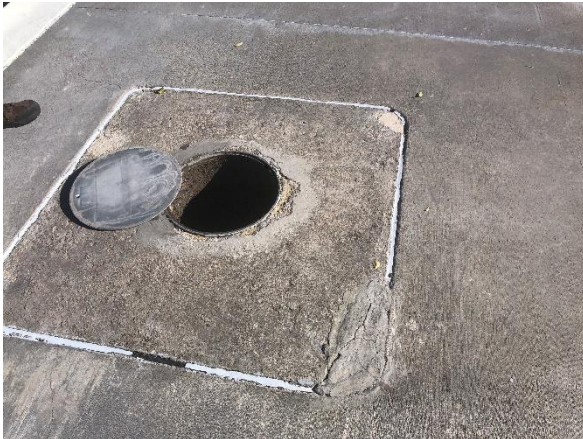
Photo #7: Overflow skimmer location.

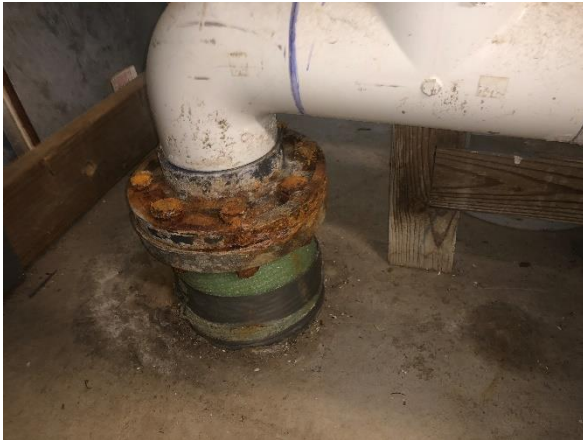
Photo #9: Transition from pool piping from mechanical room to below grade.

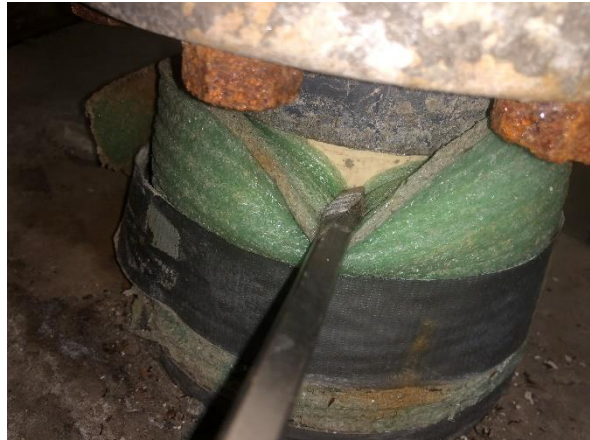
Photo #10: Further detail of Photo #9.

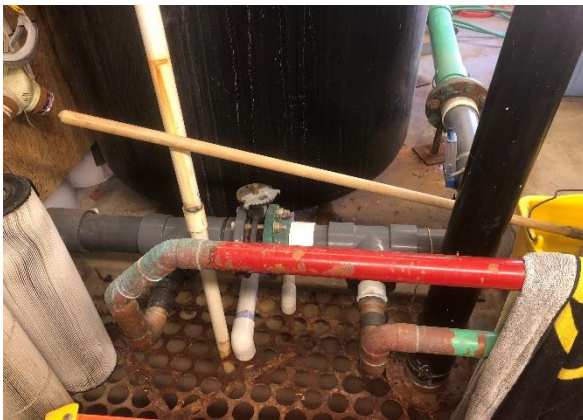
Photo #11: Backwash holding tank and pool.

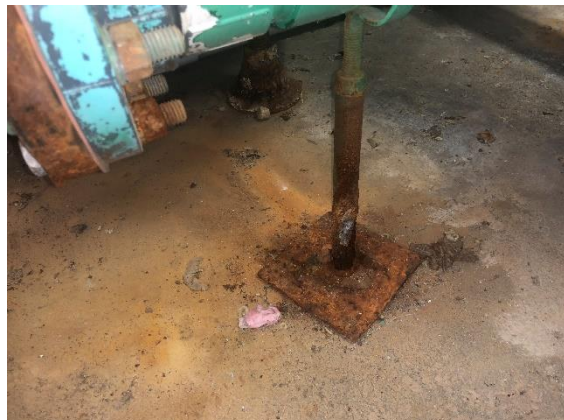
Photo #12: Corrosion of pool piping support.

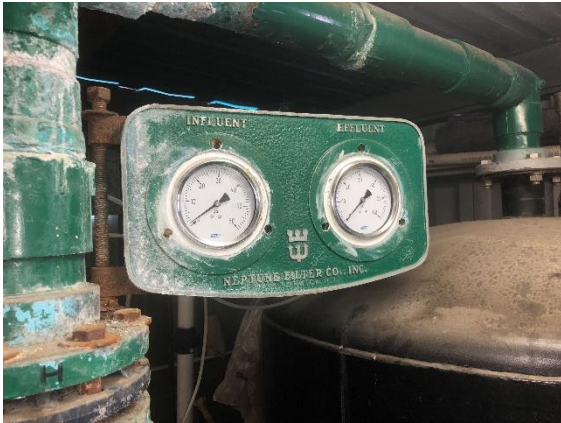
Item	Comment
Pool Filter The high rate sand filter used to filter the swimming pool is believed to be the original equipment, installed in 1966 (52 years ago). Corrosion was noted on the exterior of the filters. The assumed life expectancy is 20 years. These filters have reached their expected life and should be replaced soon.	High rate filters should be replaced as they reach the end of their useable life.
Pool Pump VFD No VFD was observed for this pool pump during the site visit.	It is industry standard to put a Variable Frequency Drive (VFD) on a pump for full size pools with pumps 5 HP or greater.
Chemical Room Storage Chemicals were stored in the pool mechanical room. Equipment room had no separate chemical storage areas (with limited access) and the point of injection was within the main equipment area.	Industry standards require chemicals to be stored in separate (locked) rooms with limited access. These rooms typically have access via exterior doors for ease and safety of delivery. Chemicals should be stored with secondary containment measures. Chemical injection into the system should occur in the chemical rooms.

Photo #13: Filter Pressure Gauges

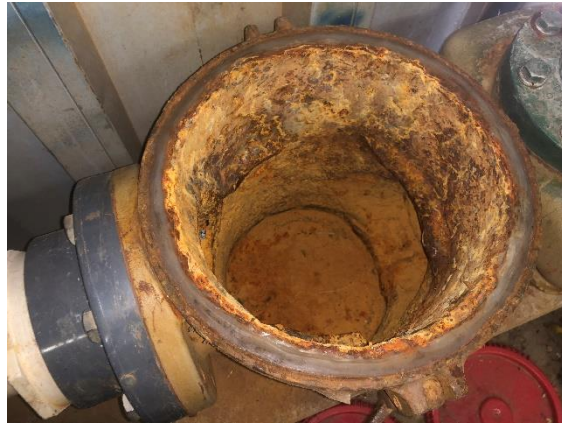
Photo #14: Corrosion at the pool strainer basket.

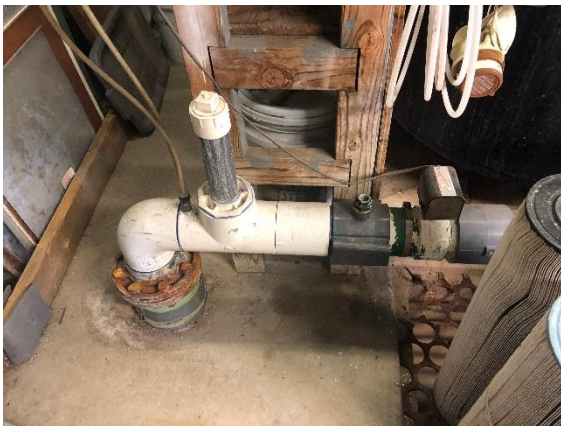
Photo #15: Chlorine and CO2 injection points

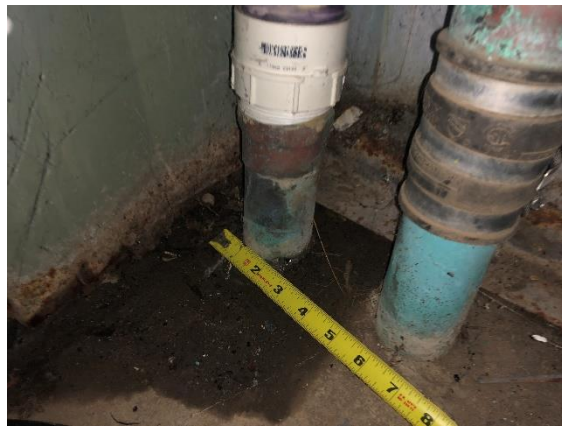
Item	Comment
<p>Pipe Sizes CCR 3.16 requires pipes to be sized such that flow velocity of piping systems shall not exceed 7 feet per second in any suction piping and 10 feet per second in any portion of the return system.</p>	<p>The pool suction piping in the room was 4” diameter, which has a capacity of 275 GPM to meet the 7-fps suction velocity. The pool currently meets code for velocity, however if the system is upsized to meet required turnover, the pipe system will have to be replaced all the way back to the pool.</p>
<p>Mechanical Room Storage CCR 3.18 outlines that miscellaneous equipment, chemicals, and appurtenances shall not be stored in the pool mechanical room. Industry standards require chemicals to be stored separately. Industry standards require chemicals to be stored in separate (locked) rooms with limited access. These rooms typically have access via exterior doors for ease and safety of delivery. Chemicals should be stored with secondary containment measures. Chemical injection into the system should occur in the chemical rooms.</p>	<p>Chemicals were stored in the pool mechanical room. The pool mechanical room did not have sufficient space around equipment. See below for industry standard comments on mechanical room. Equipment room had no separate chemical storage areas and the point of injection was within the main equipment area.</p>

Photo #16: Suction piping
